TO 1F-15C-3-2

Figure 3-55. Main Structure (Sheet 1 of 7)

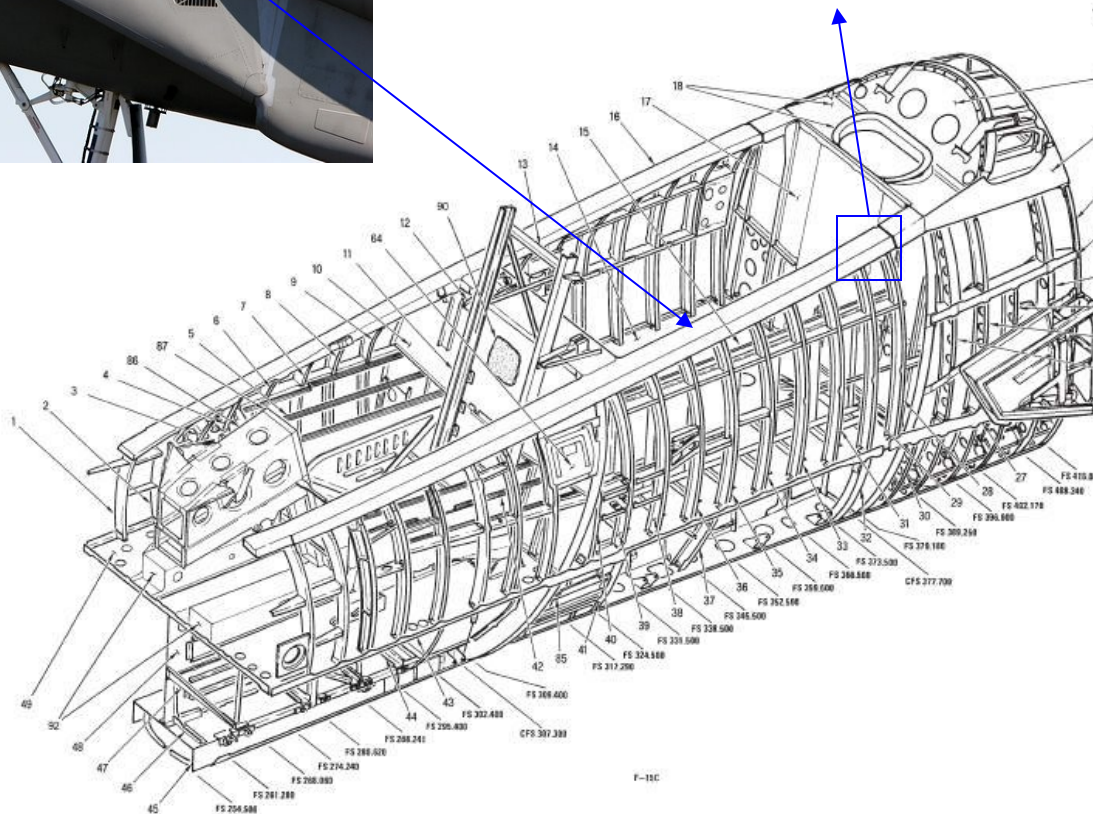
**Location of
Cracks Found
During
Inspections**

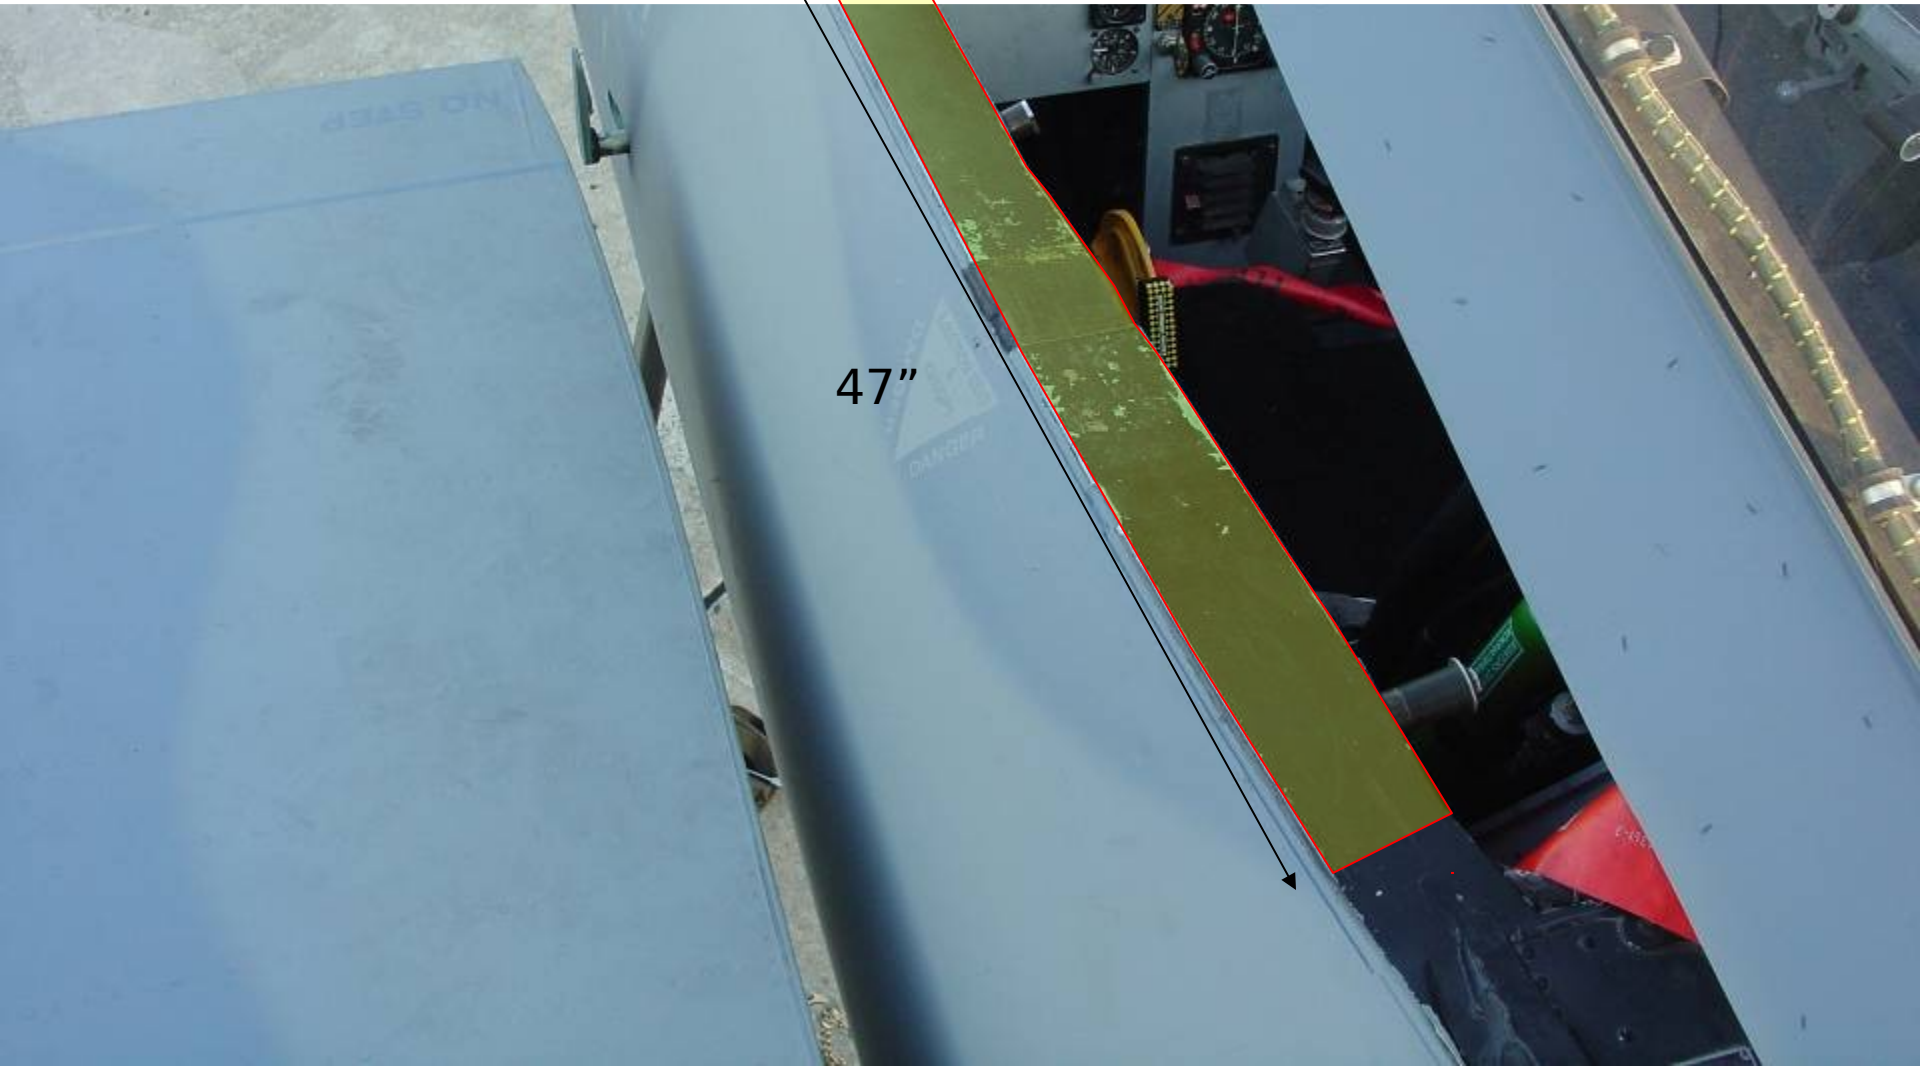
Figure 3-55. Main Structure (Sheet 1 of 7)

New Inspection Area Two Seat F-15 (Typical Left & Right Side)

**New
Inspection
Focus**
